Adhesion Testing of Firebricks From Launch Pad 39A Flame Trench After STS-124

Paul E. Hintze
NASA Kennedy Space Center, Florida

Jerome P. Curran
ASRC Aerospace Corporation, Kennedy Space Center, Florida

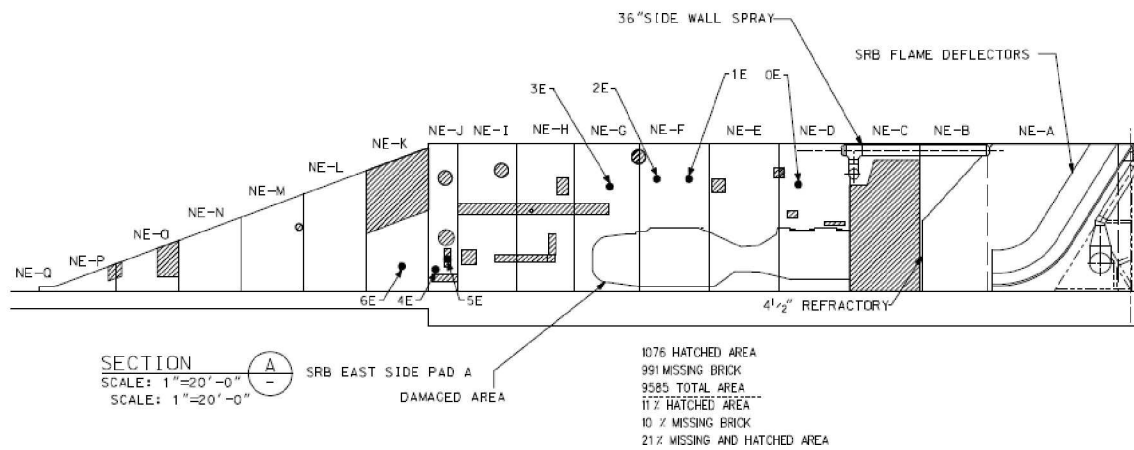
Figure 3. Core locations on the east wall of the trench

Cross-hatched areas sounded hollow according to the hammer test.

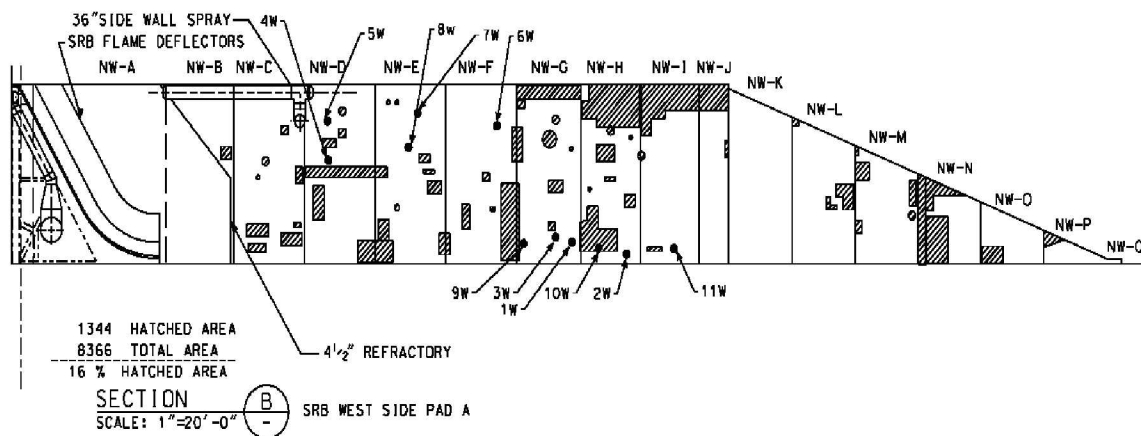
Figure 5. Core locations on the west wall of the trench

Cross-hatched areas sounded hollow according to the hammer test.

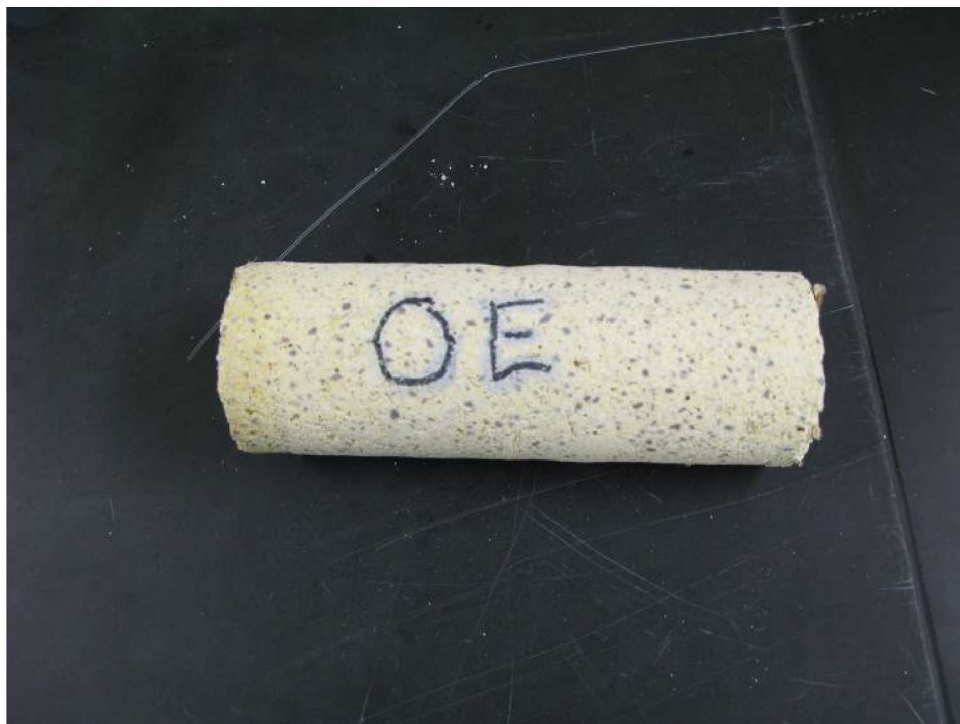
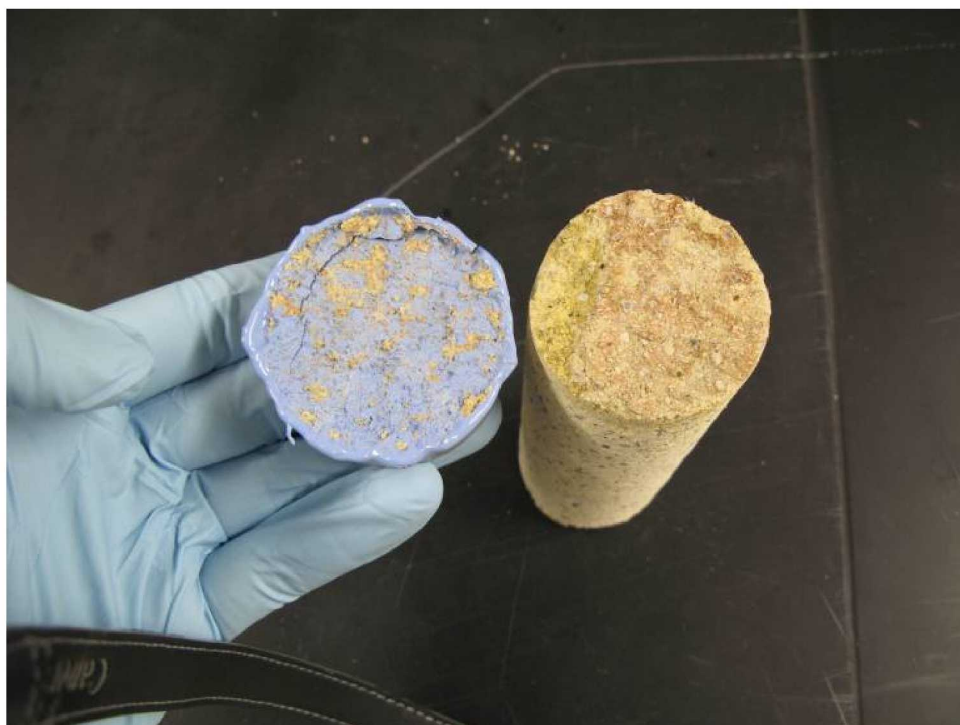
The pull test failed at the adhesive/firebrick interface.

Figure 6. Core 0E – successful test: failed at 60 psi (side image of core and outer surface of core and pull stub).

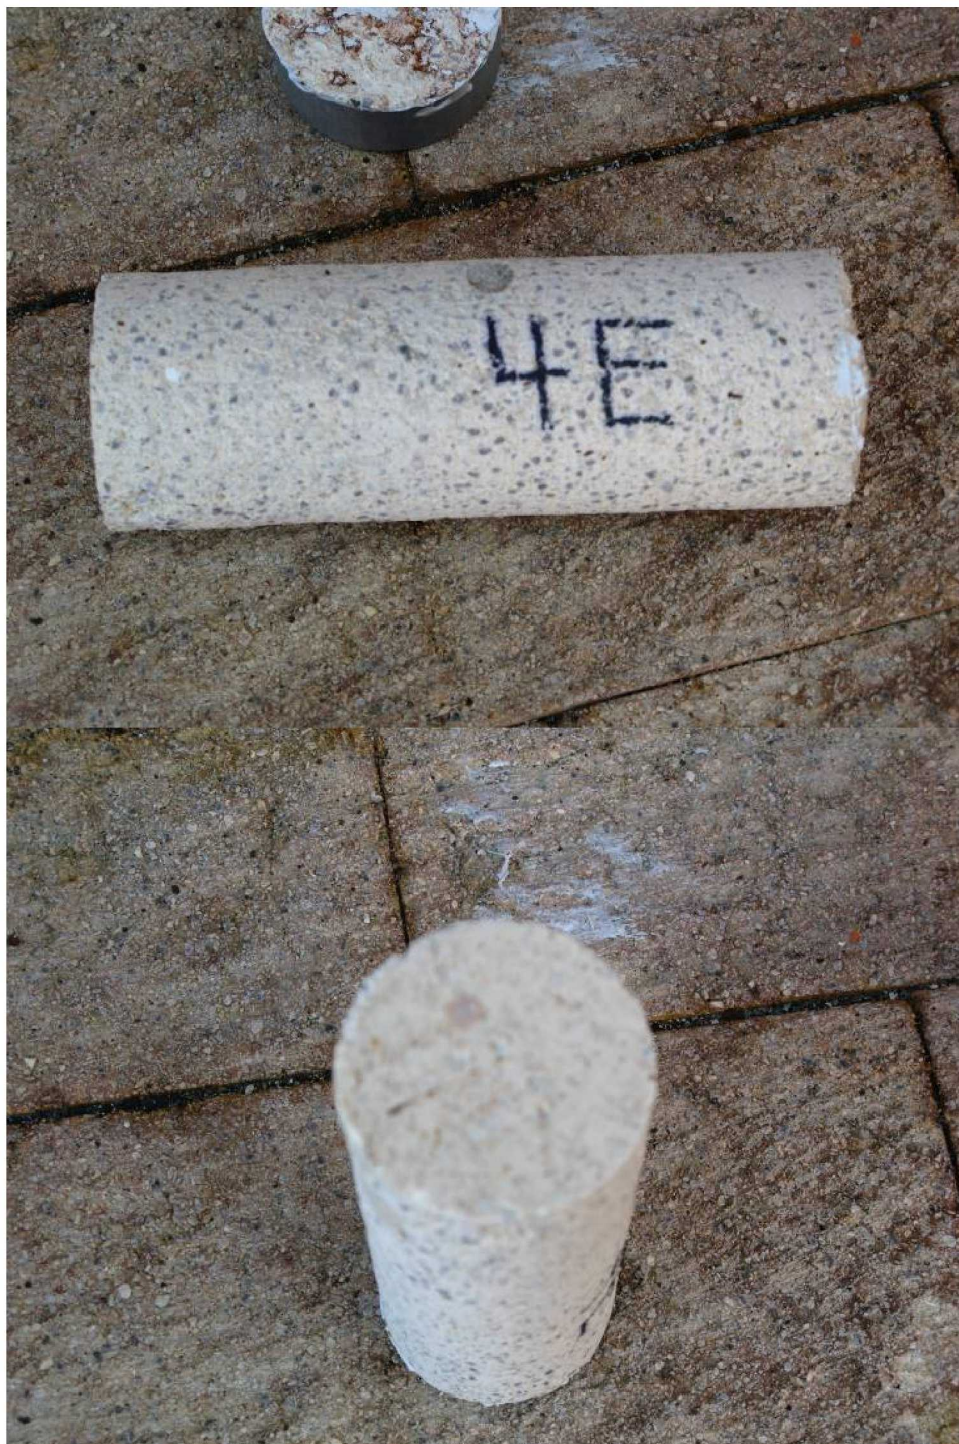
No epoxy was found on the core

Figure 14. Core 4E – side image of core and back end of core, closest to the concrete wall

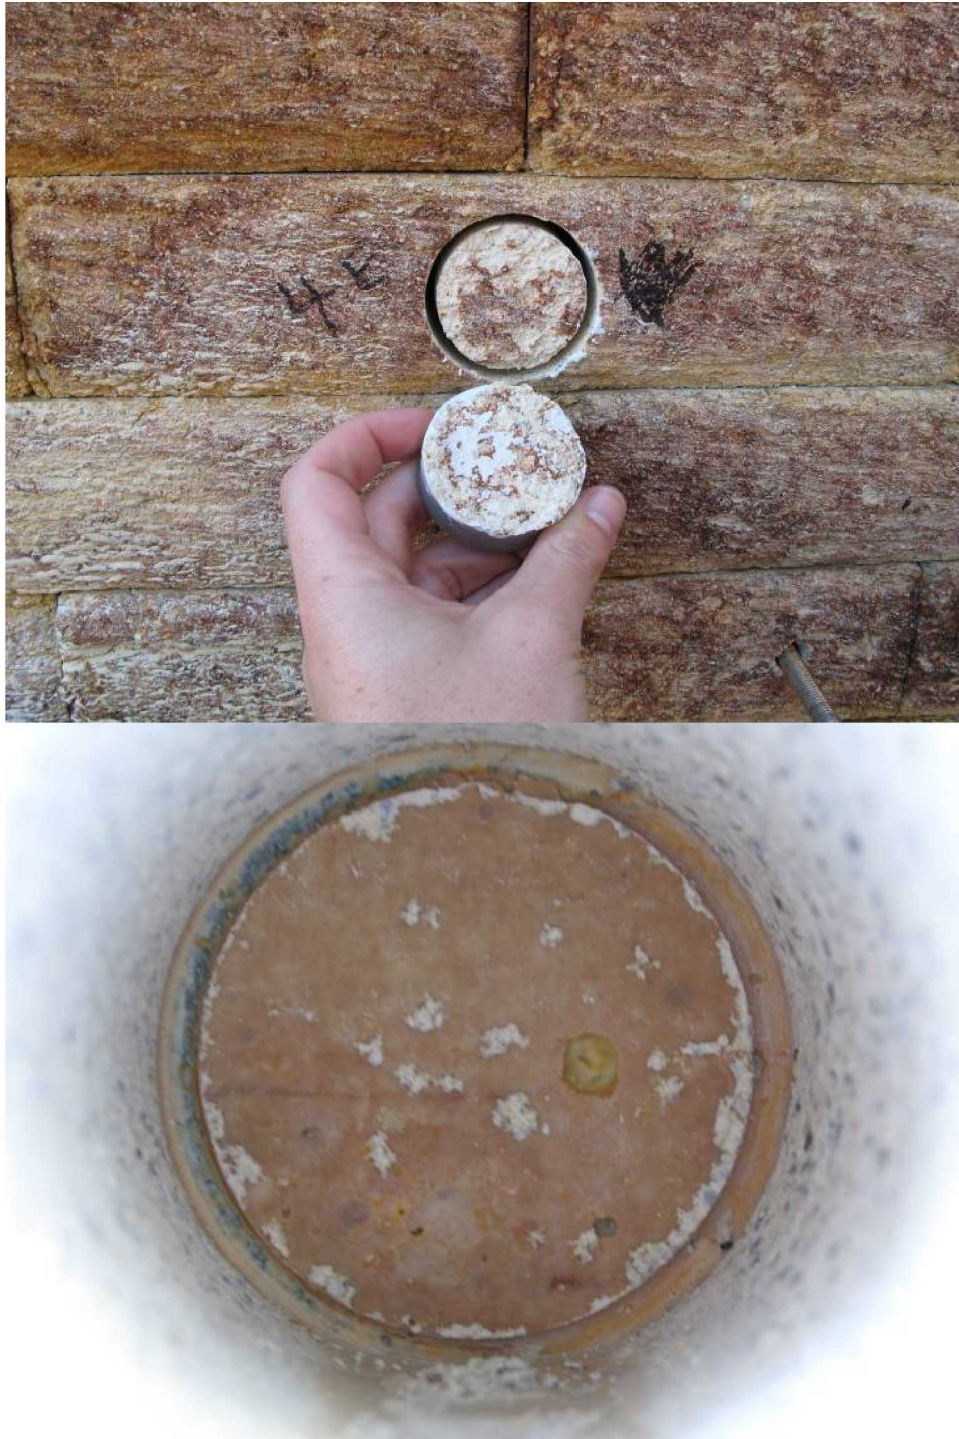
Figure 15. Core 4E – successful test: failed at 114 psi (pull stub and core face and the image inside the brick after the core was removed)

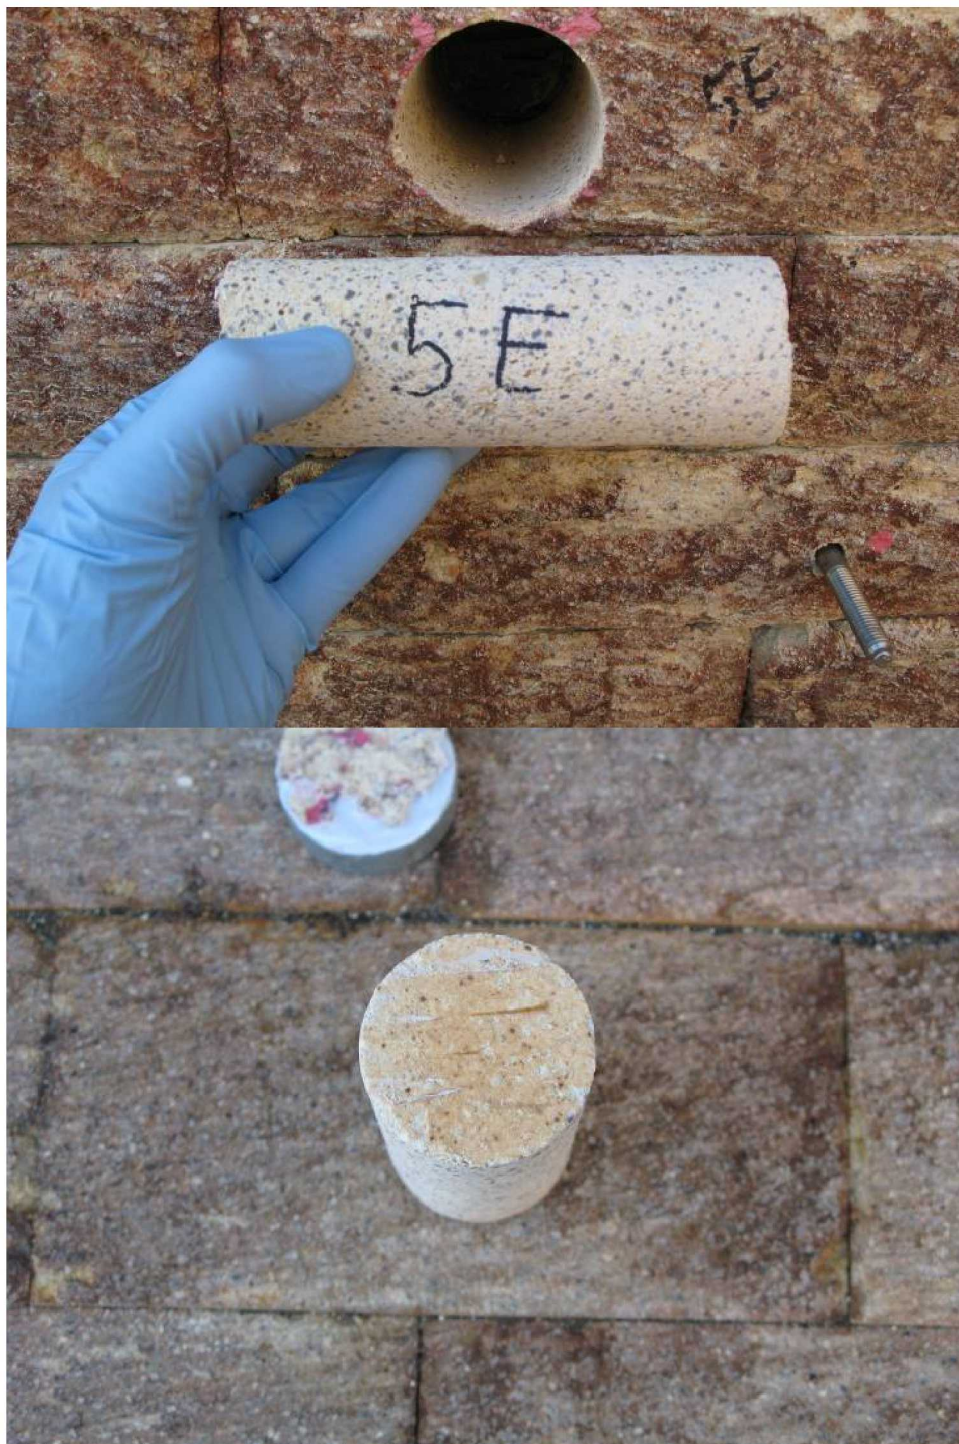
No epoxy was found on the core.

Figure 16. Core 5E – side image of core and back end of core, closest to the concrete wall

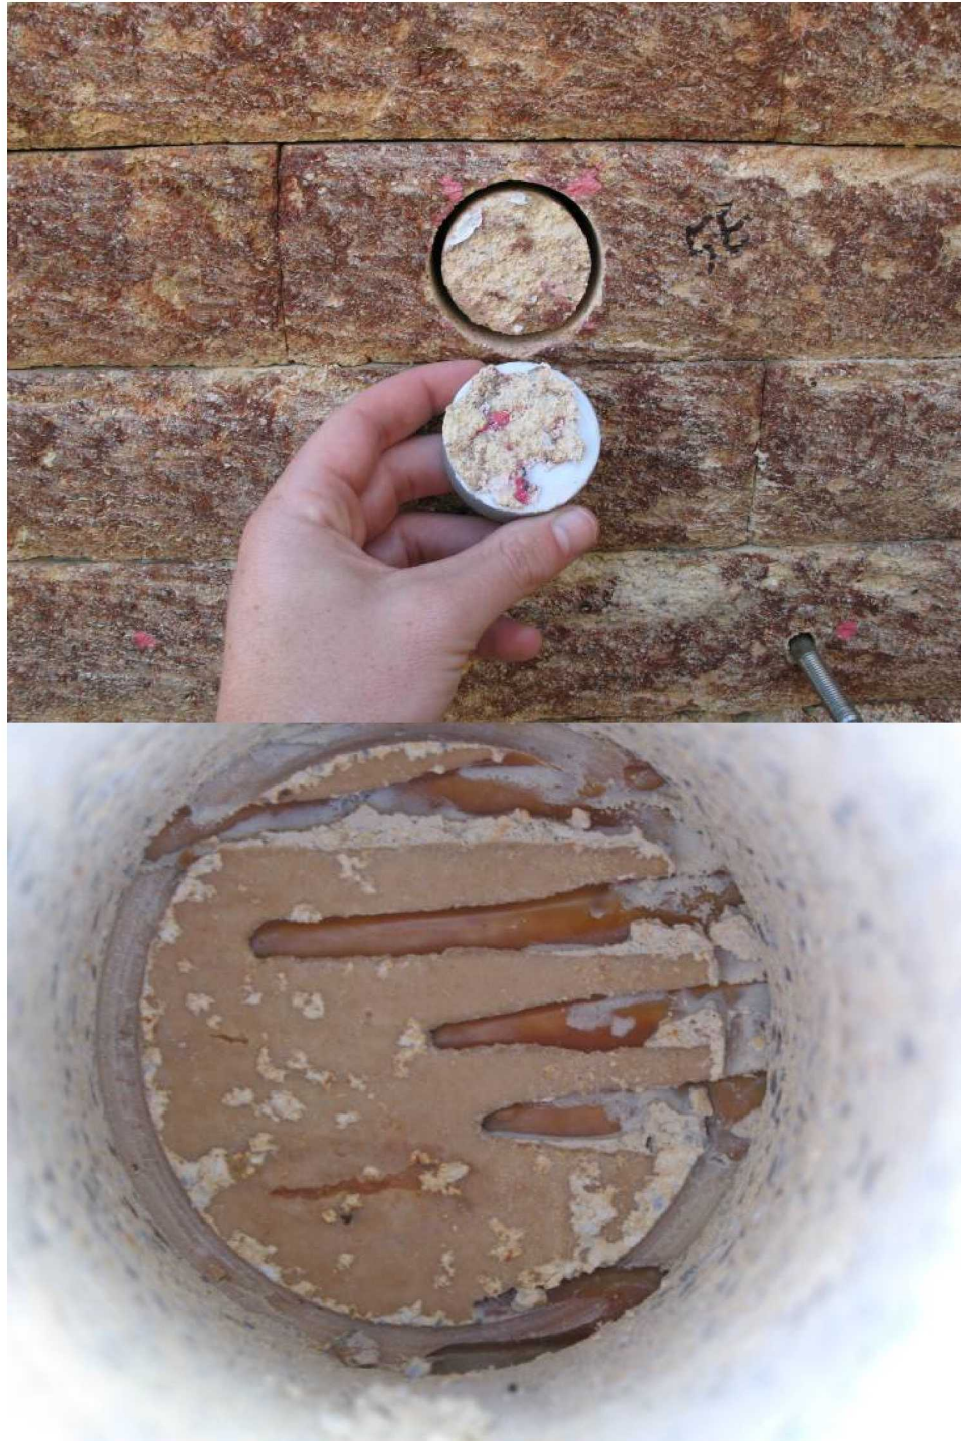
Figure 17. Core 5E – successful test: failed at 82 psi (pull stub and core face and the image inside the brick after the core was removed)

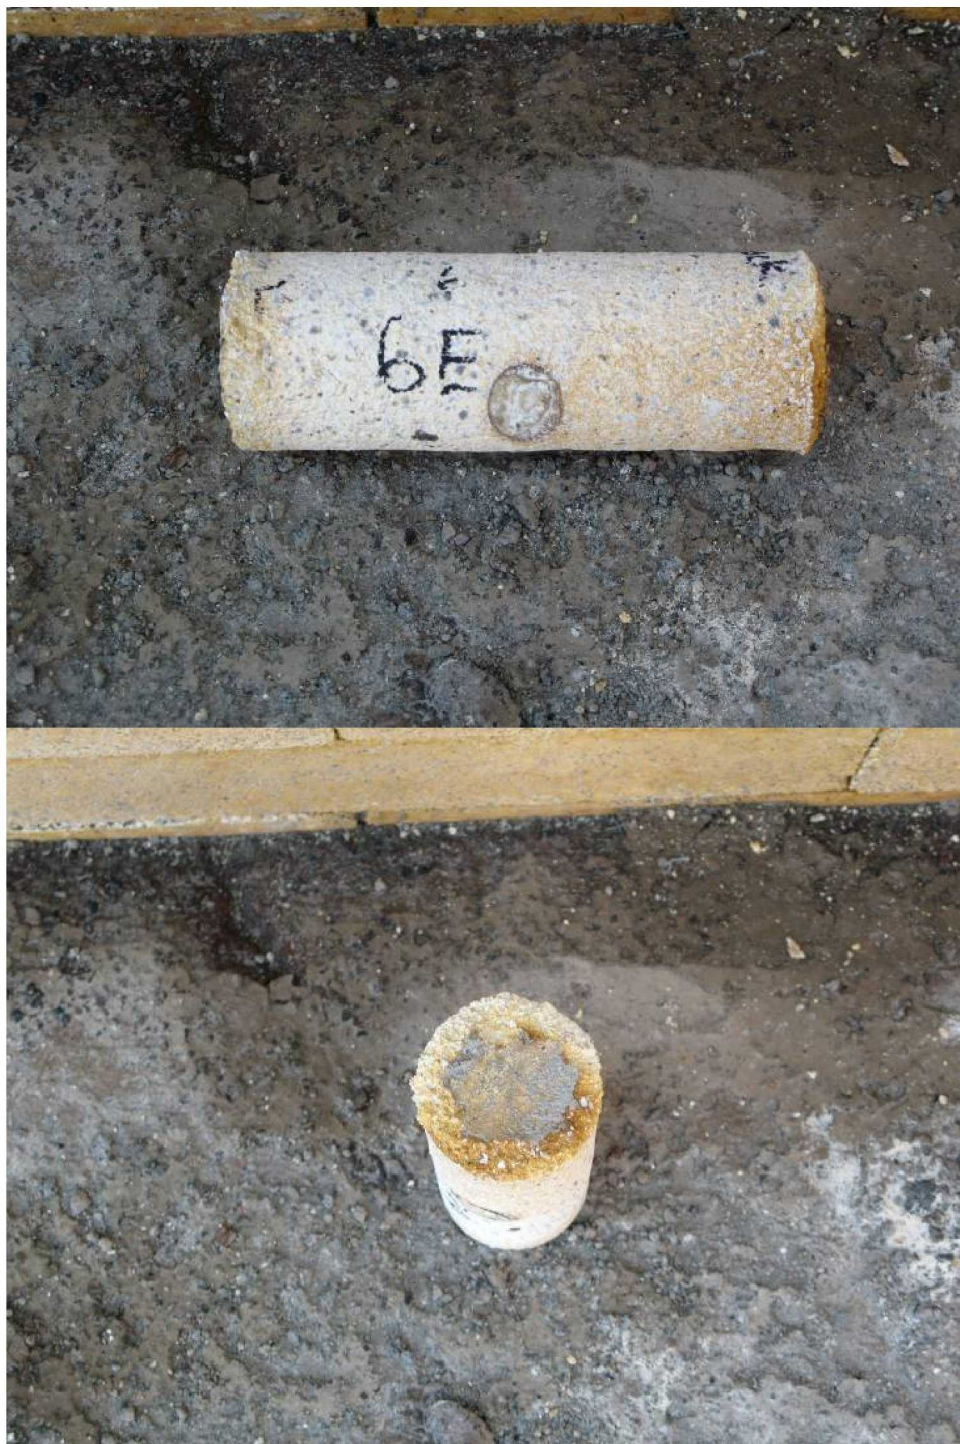
Some epoxy was found on the core.

Figure 18. Core 6E – side image of core and back end of core, closest to the concrete wall

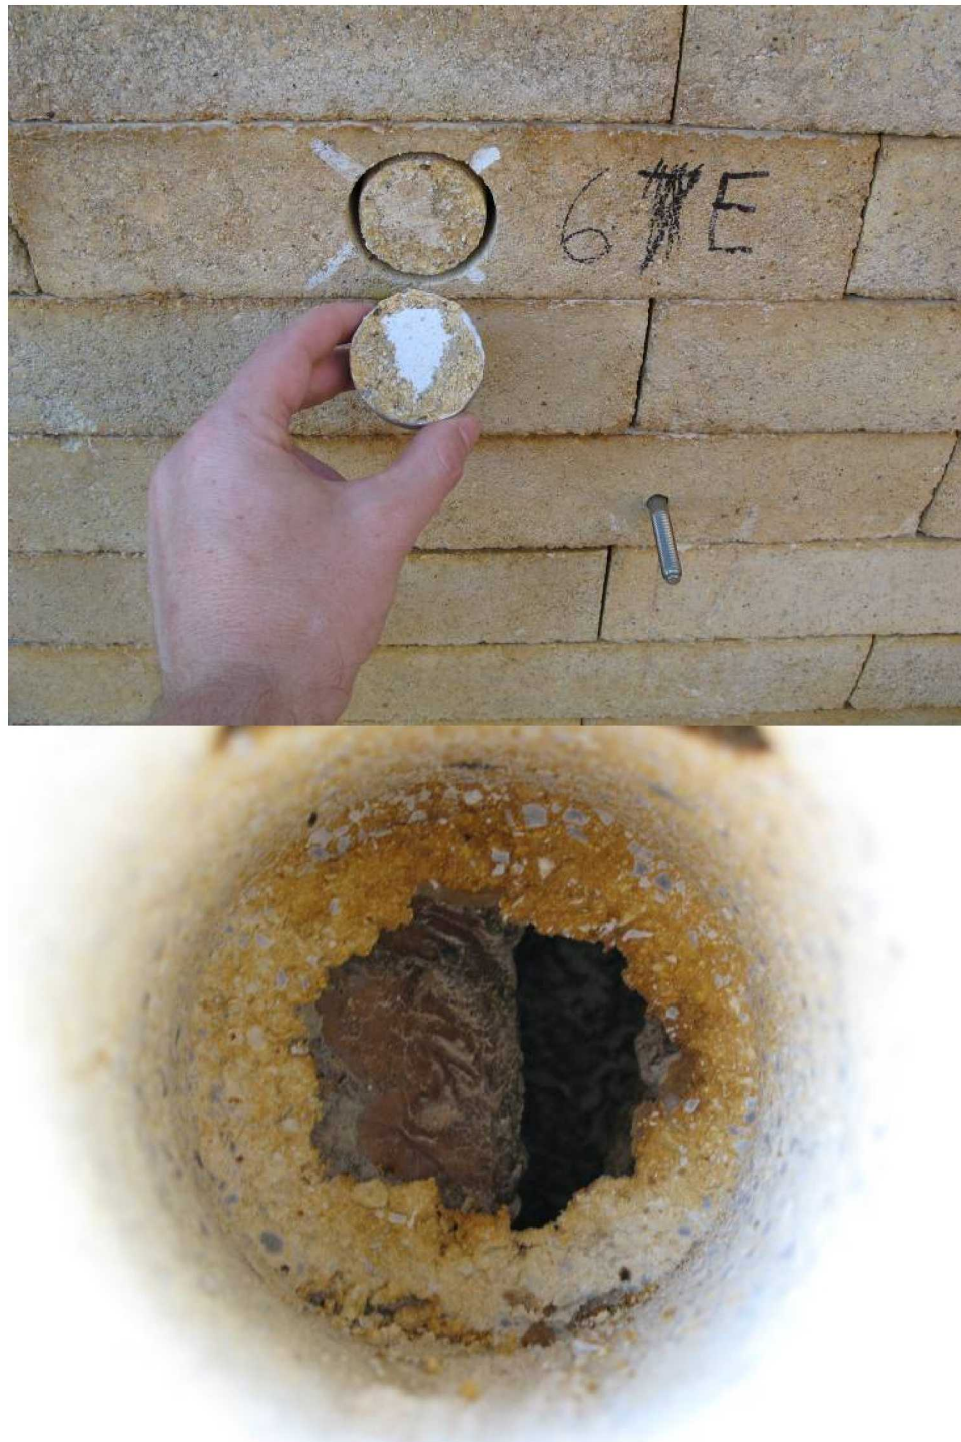
Figure 19. Core 6E – successful test: failed at 107 psi (image of pull stub and core face and the image inside the brick after the core was removed)

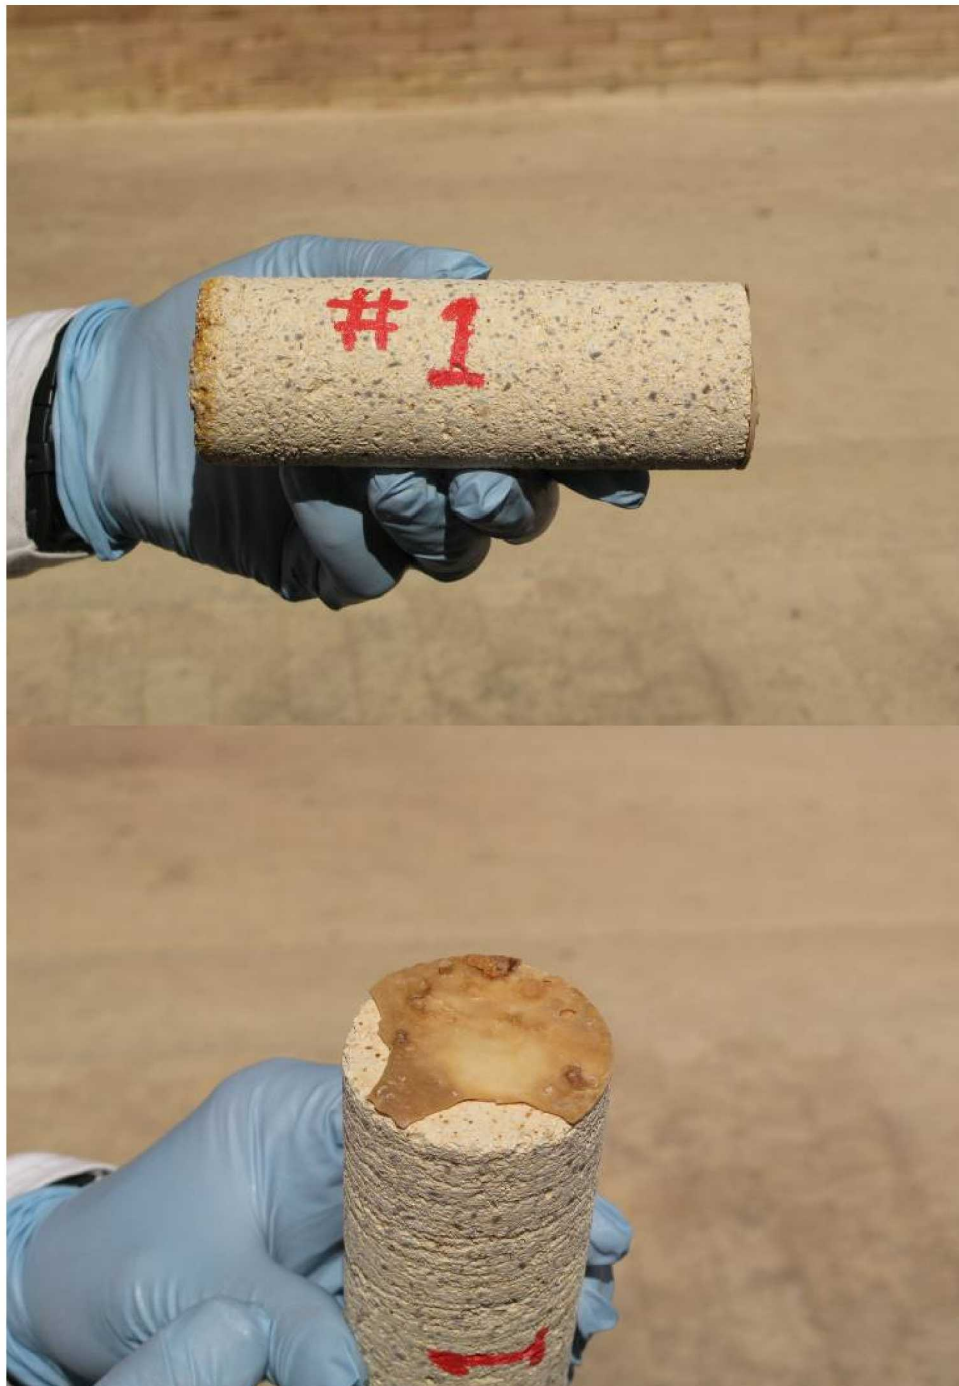
Core became loose during drilling. Then an additional section of the concrete was cored out. Epoxy covered the entire inner surface when pulled, but it flaked off easily

Figure 20. Core 1 – side view of core and inner surface of core

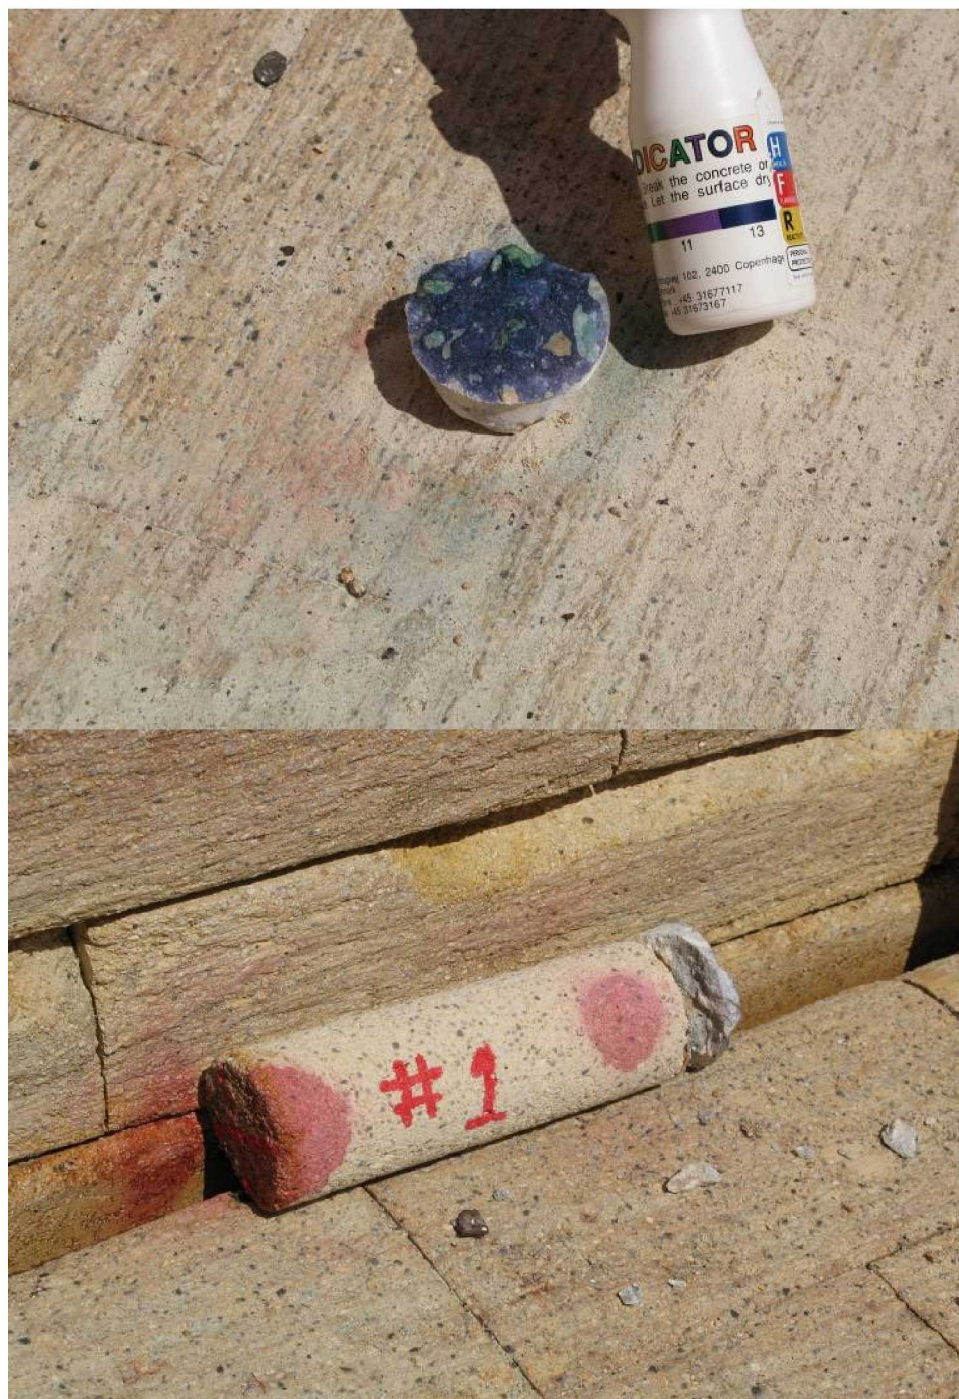
A universal pH indicator was sprayed on core 1 from the west wall and the small amount of concrete that was removed after drilling. The pH of the concrete was found to be about 13, which is appropriate and indicates the concrete is in good shape. The pH of the firebrick was checked at the face and near the back side. The pH of the back side appeared to be near 11, while the face was more acidic with a pH of 5. The proper pH for the bulk of the firebrick is unknown, but it was clear that the face was more acidic than the bulk.

Core became loose during drilling. After coring the firebrick, an additional section of the concrete was cored out. The pH testing was done on the concrete and firebrick.

Figure 22. Core 1 – pH of the concrete was about 13, which is appropriate for concrete, and pH of the brick was more acidic

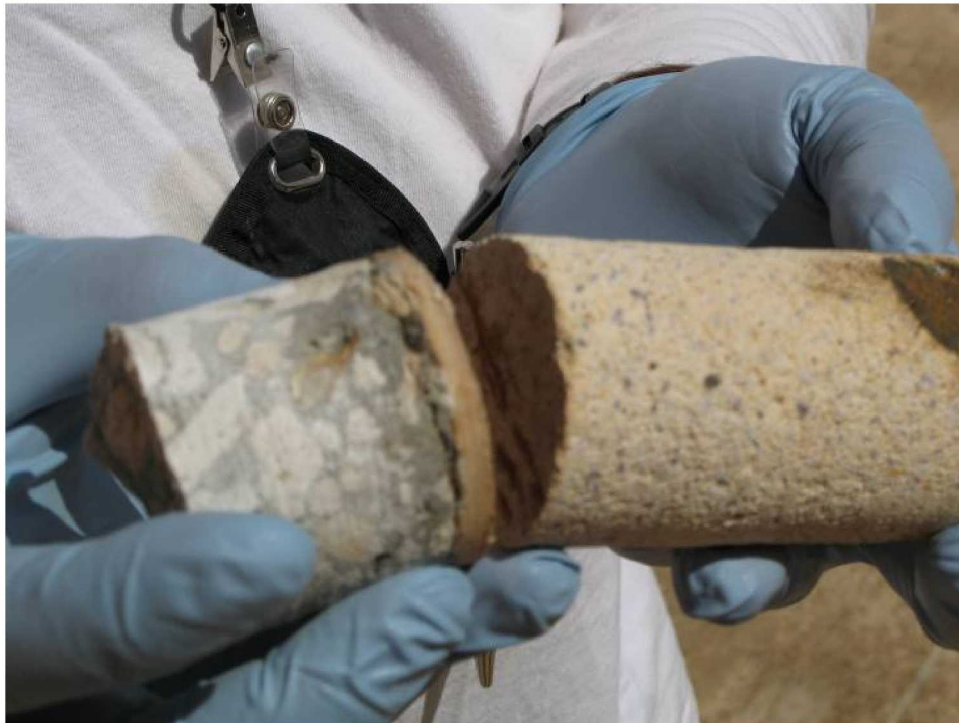
The core remained attached to the concrete wall after drilling to a depth of 6 inches from the face of the brick. Drilling continued after the initial 6 inches to try to get a complete core. There was adhesion failure between the firebrick and the epoxy when the deeper drilling occurred. Hammer testing showed this to be a solid brick.

Figure 23. Core 2 – adhesion failure

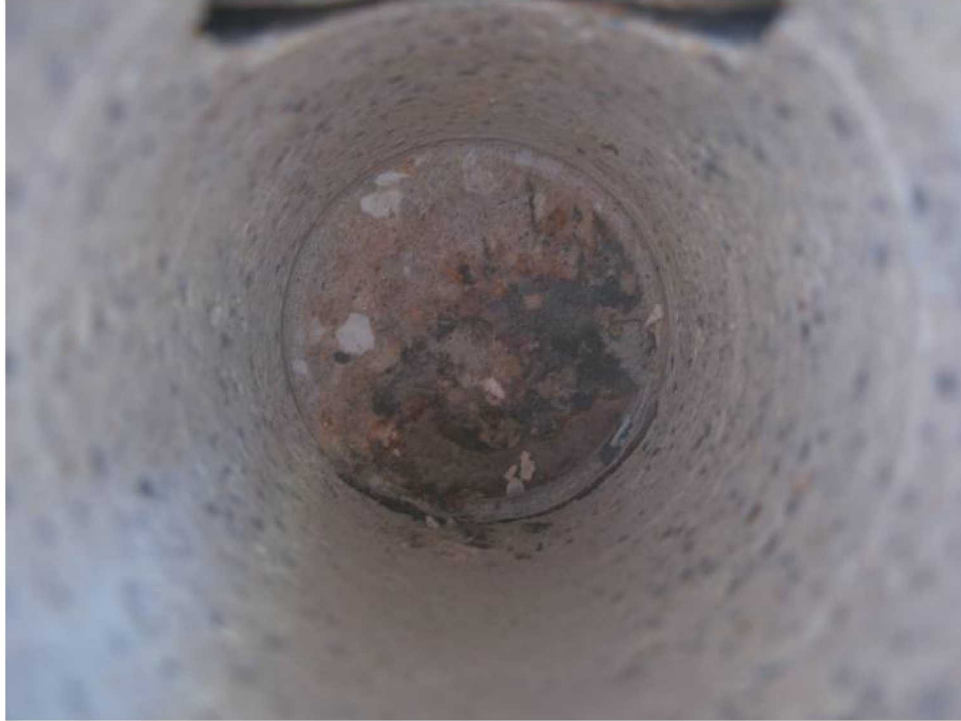
This was the only pull test that resulted in the entire core was removed.

Figure 35. Core 8W – inside the brick after the core was removed

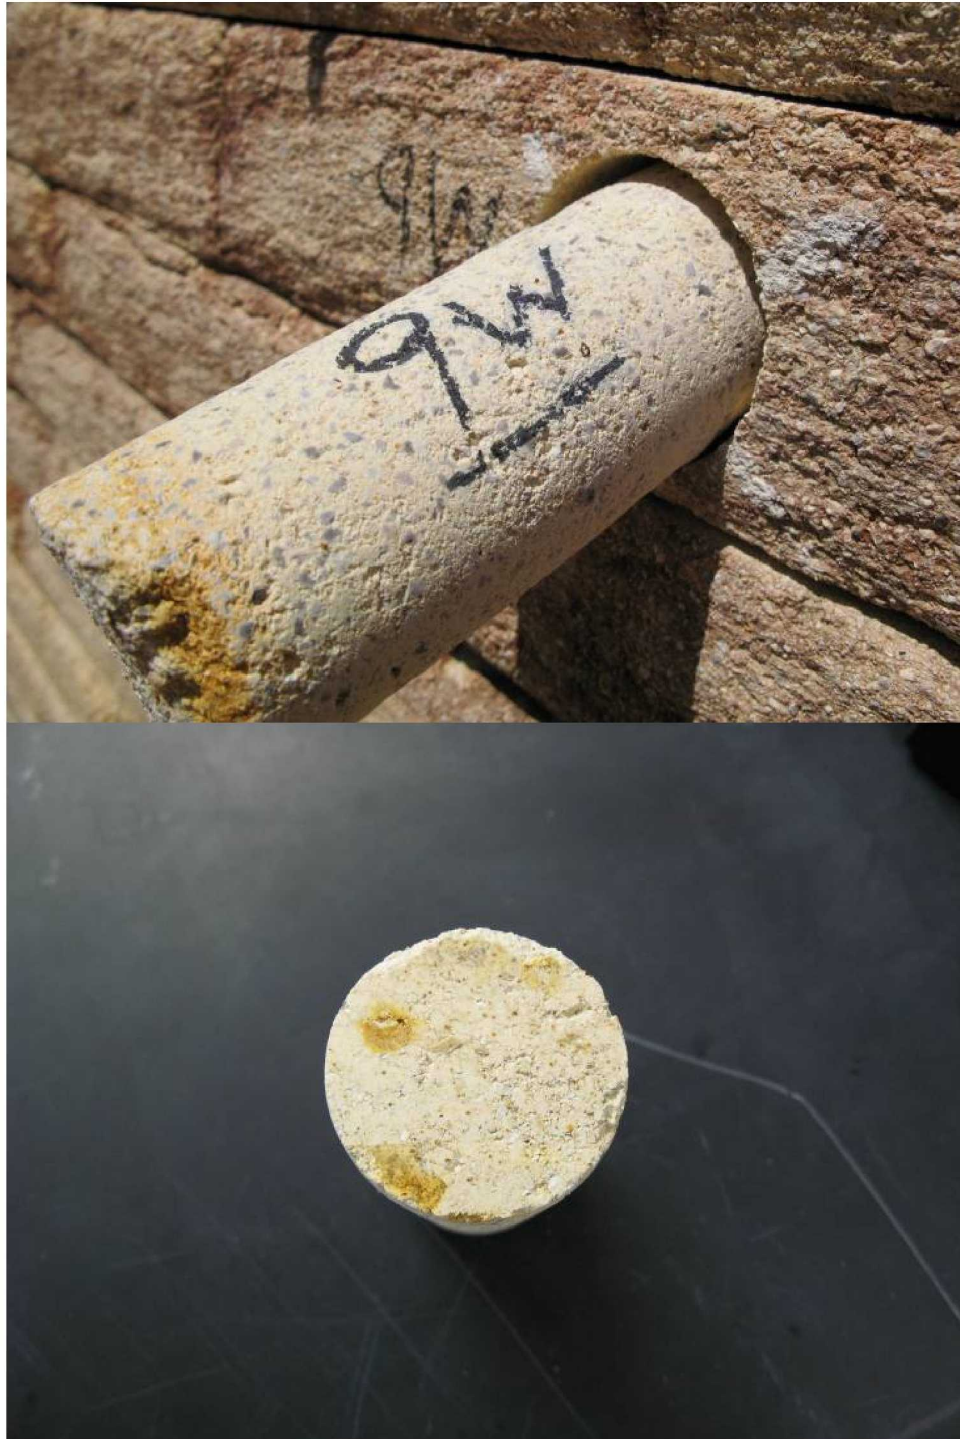
No epoxy was found on the core.

Figure 36. Core 9W – side image of core and back end of core, closest to the concrete wall

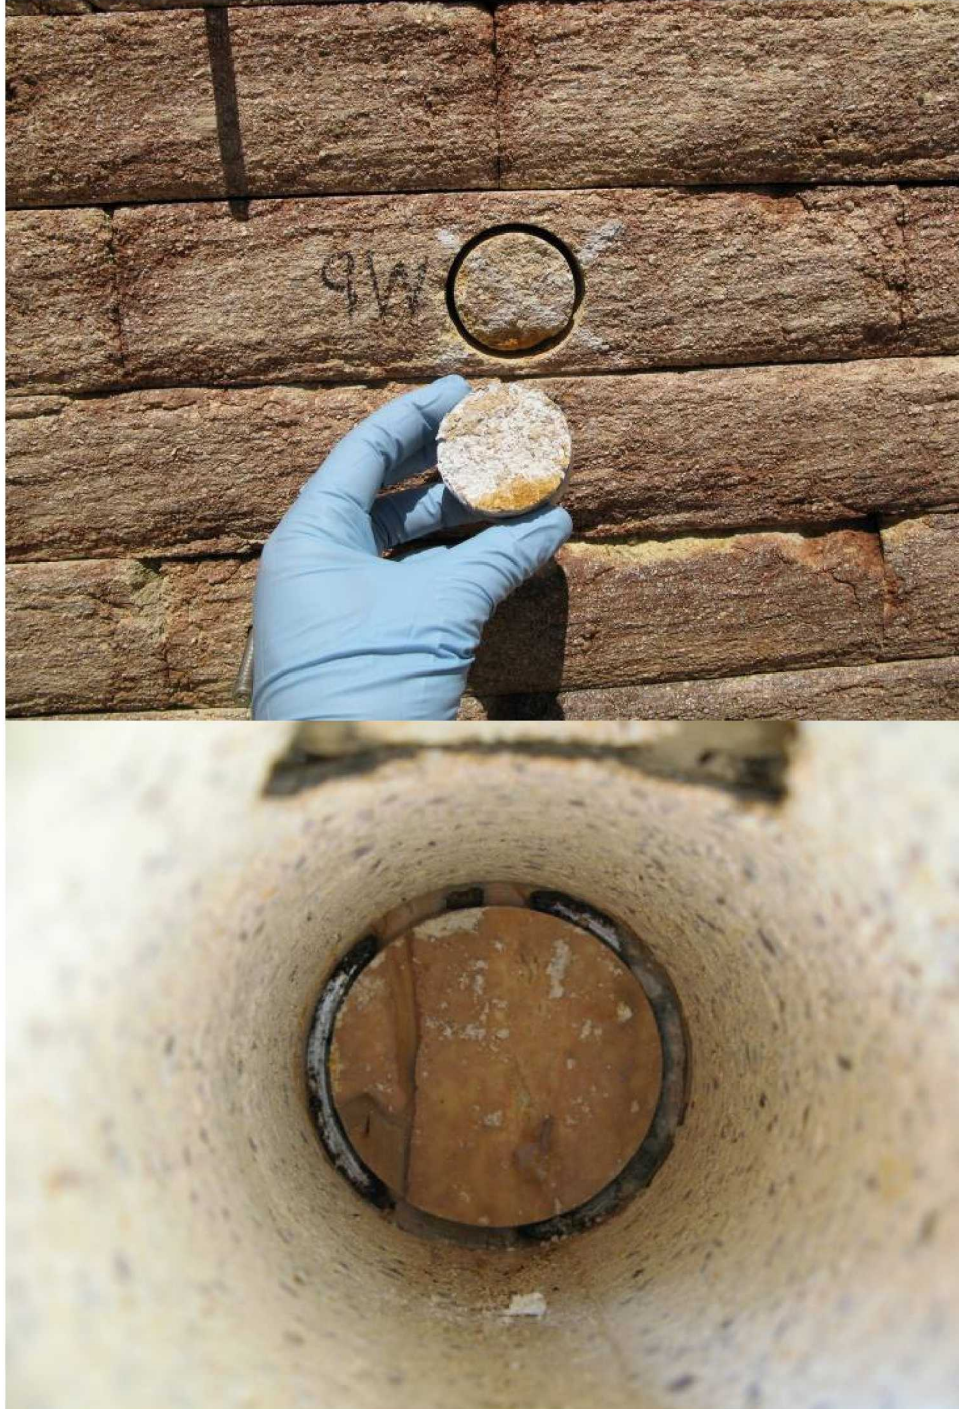
There is evidence of corrosion shown at the concrete/firebrick interface.

Figure 37. Core 9W – successful test: failed at 54 psi (pull stub and core face and inside the brick after the core was removed)

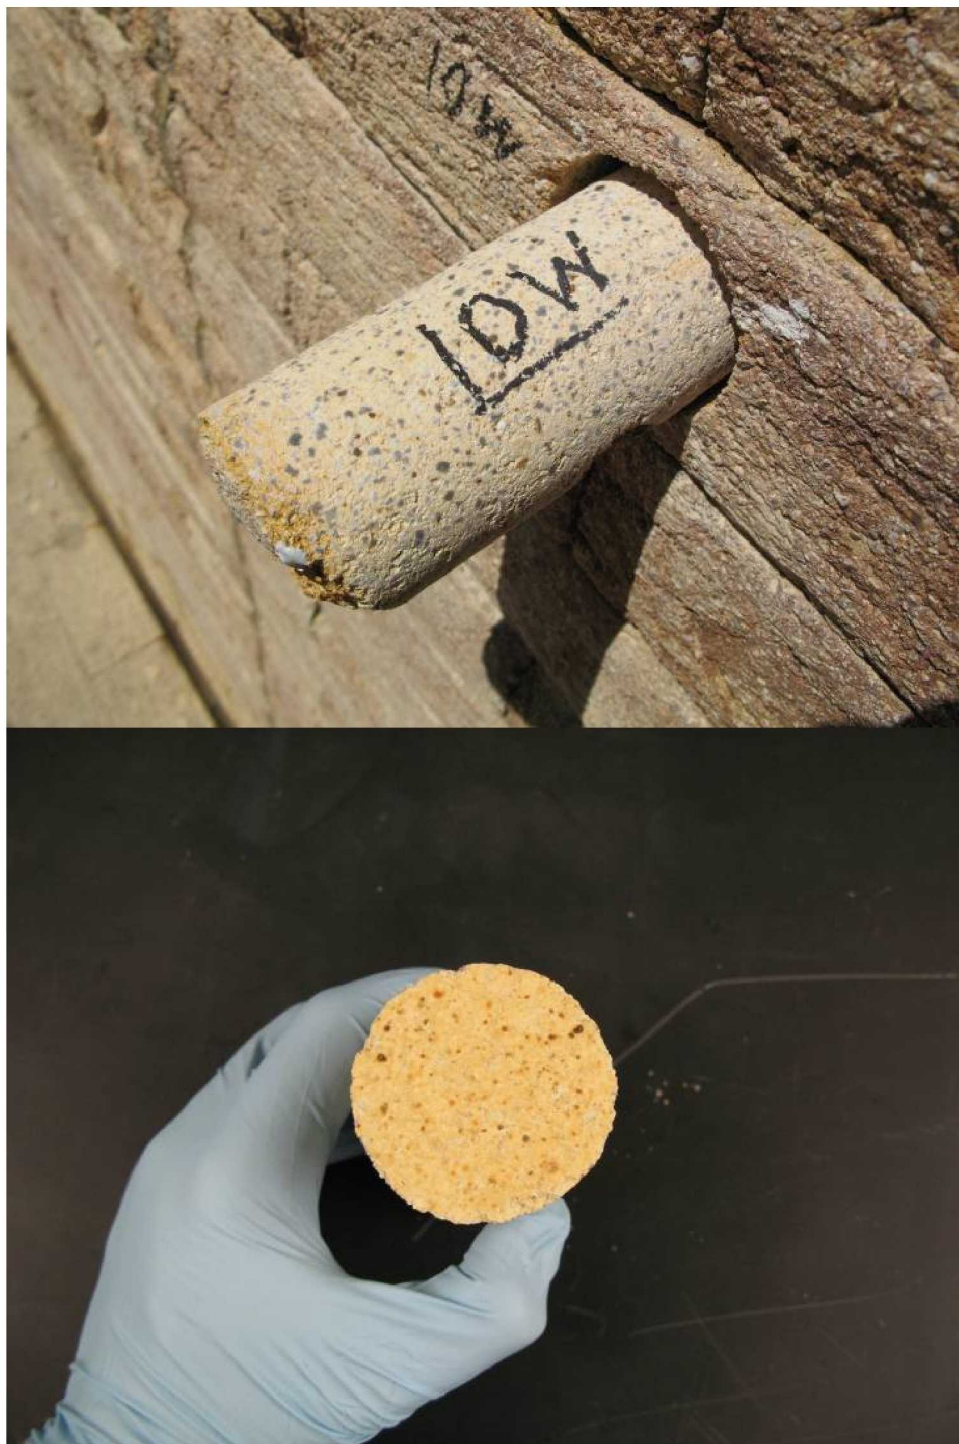
No epoxy was found on the core.

Figure 38. Core 10W – side image of core and back end of core, closest to the concrete wall

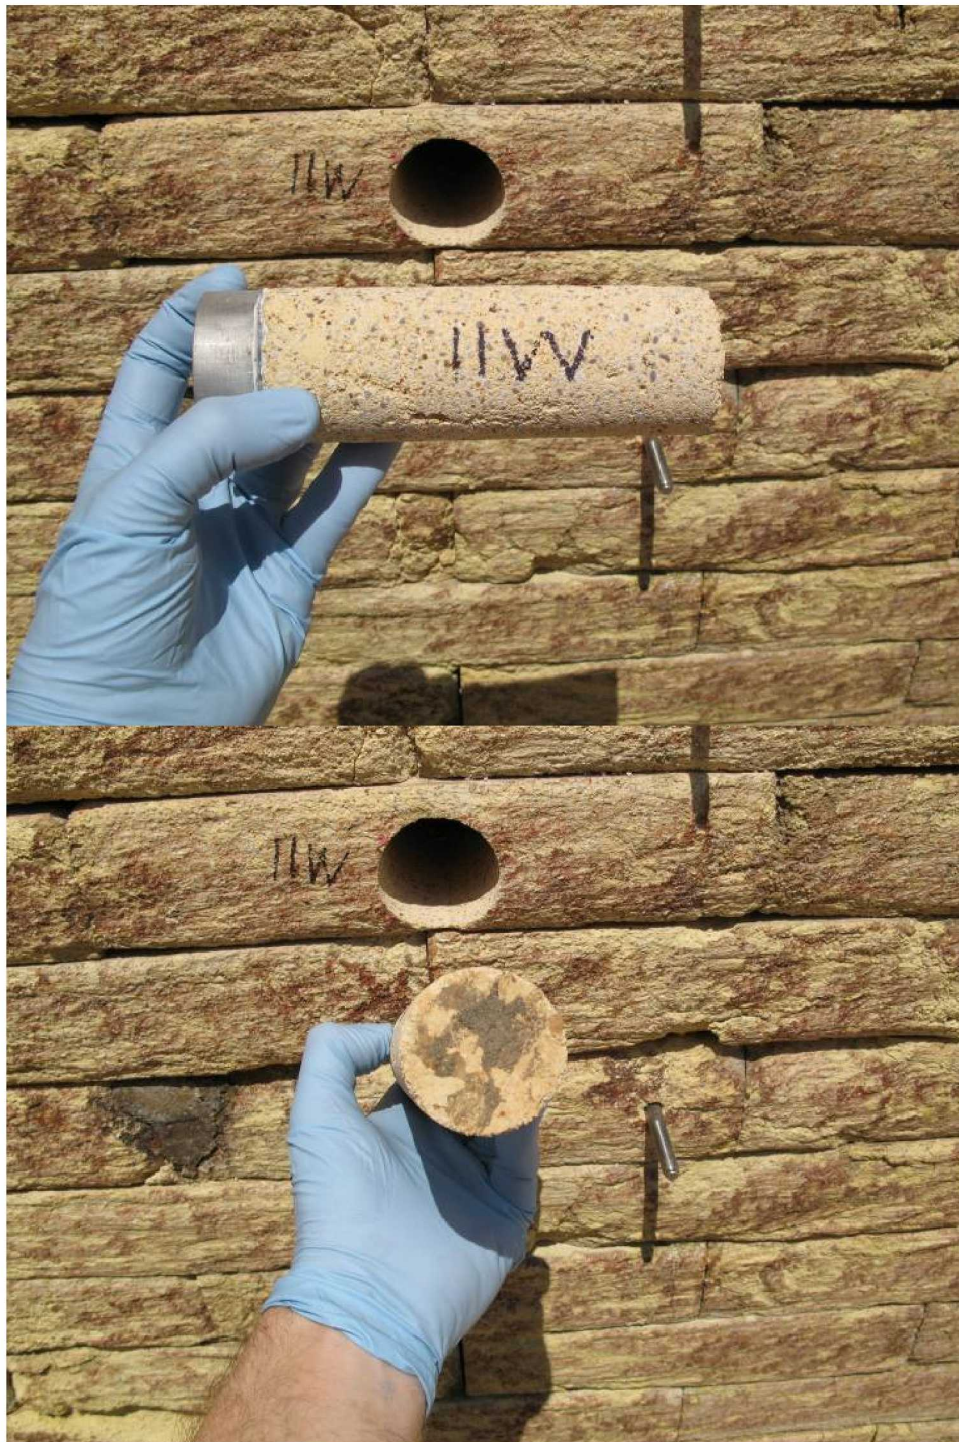
This core came out as adhesion testing began, so the pull stub was still attached. Some epoxy was found on the core.

Figure 40. Core 11W – side image of core and back end of core, closest to the concrete wall
